**Power Generation All-Risk Report
City of Dover
McKee Run and VanSant Generating Stations
Dover, DE 19904, USA.**

Date of Survey: March 09, 2017

Inspected by:

Mr. Neal Grabow, N-Tec Services, Energy Loss Prevention Consultant

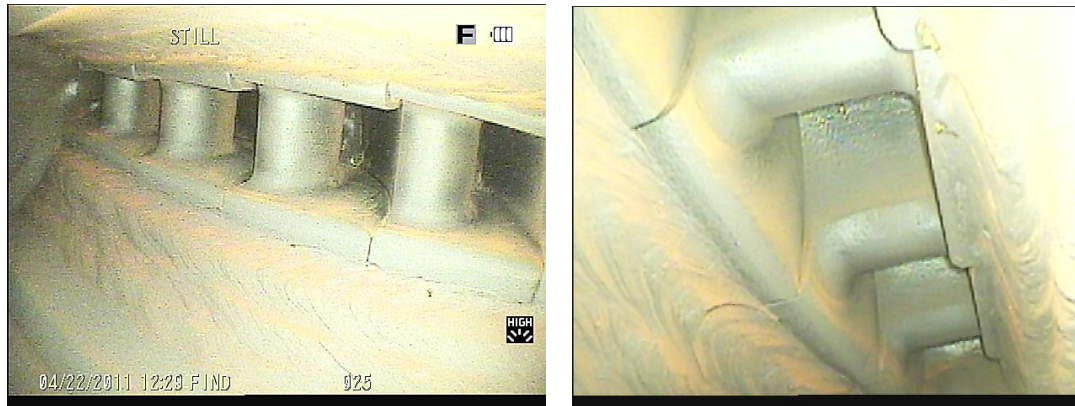
Unit 1 2011 Spring Outage

The turbine valves were dismantled by Sulzer Turbo Services. The nozzle block area was inspected with borescope while the valves were removed. Pitting conditions were reported in the nozzle block area.

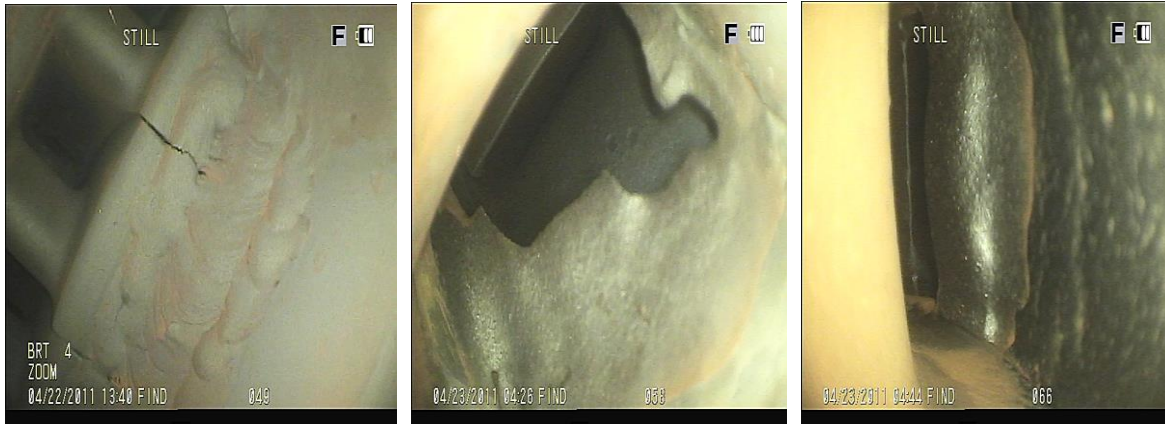
Unit 2 2011 Spring Outage

The turbine valves were dismantled for inspection. Throttle valve shaft was found to be bent during Sulzers break down and inspection of the assembly. A new shaft was manufactured by DESS machine shop. The new shaft was installed and tested OK. A borescope inspection of the nozzle block area was conducted. Significant pitting, linear indications and deterioration was observed.
